## Ultrasound Identifies Hidden Transformer Defect and

# HELPS PAPER MILL AVOID NEARLY \$1 MILLION IN RISK

The facility operates a critical paper production line powered by a 10,000 kVA transformer (13.8 kV to 2.3 kV) supplying a paper machine. This asset is essential to continuous operations, where downtime is valued at approximately \$25,000 per hour. As part of a proactive reliability program, the site performs quarterly ultrasound and infrared inspections in addition to routine oil analysis and visual inspections.

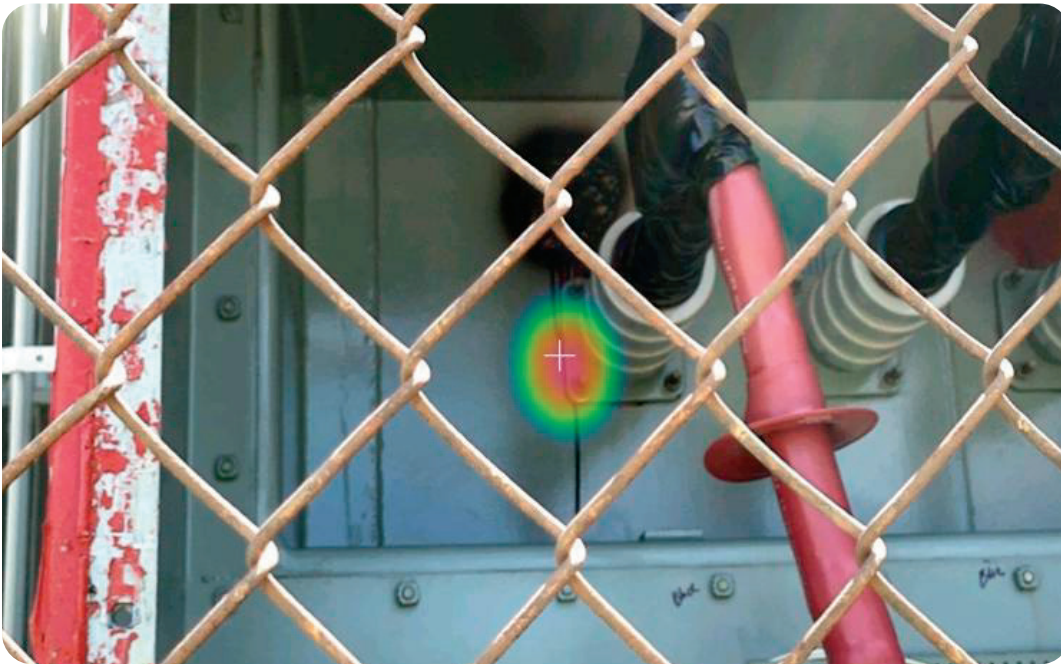
Si2-PRO Acoustic Camera identification of the sound source at the transformer bushing connection.

The source of the problem was traced to two loose bushing clamp nuts.

Technicians tightened the loose bushing clamp nuts by approximately one-eighth of a turn.

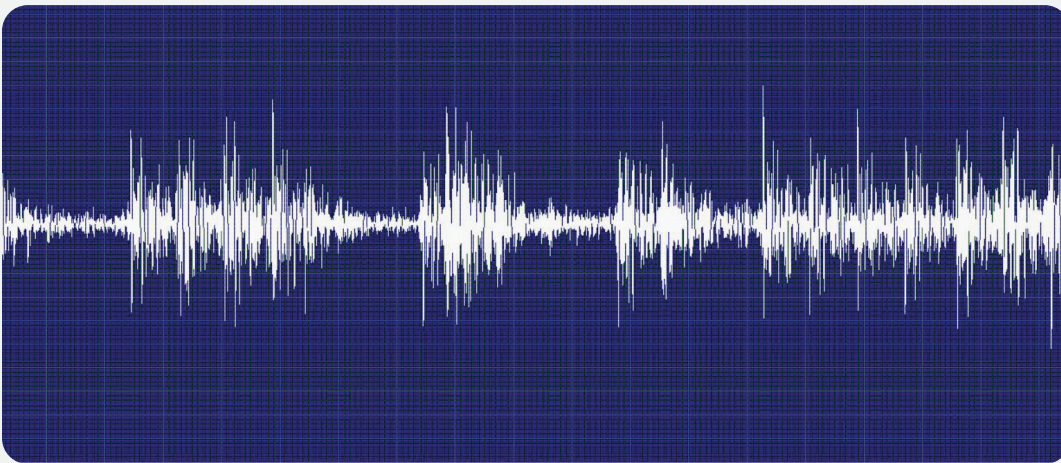
Ultraprobe 10,000 time waveform analysis showing impacting and ringdown associated with the transformer defect.

Analysis showed the nuts vibrating due to 60 Hz harmonics. This vibration produced impact and ring-down signatures visible in the ultrasound data. As the nuts vibrated, small intermittent arcs were generated, appearing in the time waveform analysis and stopping when the vibration ceased.

Because the arcing was intermittent and generated little heat, no thermal signature was present. As a result, the defect remained invisible to infrared inspections despite posing a significant reliability risk.

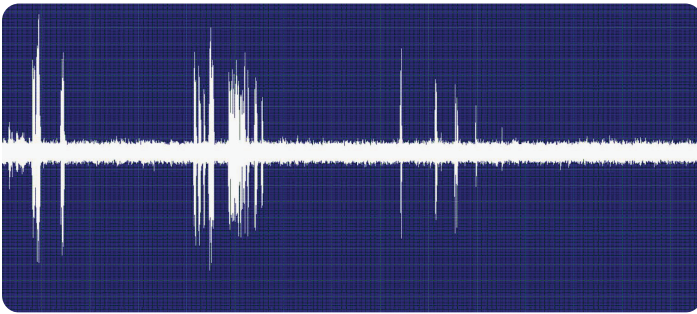
Ultrasound analysis identified intermittent arcing associated with the loose bushing connection.

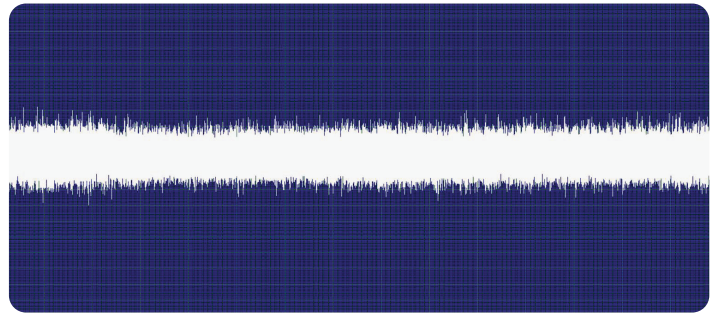
Following re-energization, ultrasound verification scans confirmed that the vibration, arcing, and abnormal acoustic signatures had been eliminated. No anomalies were detected during subsequent inspections.

Post-repair verification scan confirmed the elimination of the vibration, arcing, and abnormal acoustic signatures.
